Immediate Implant Placement with Osteotomes for Bone Expansion

April 22, 2014 - October 10, 2014

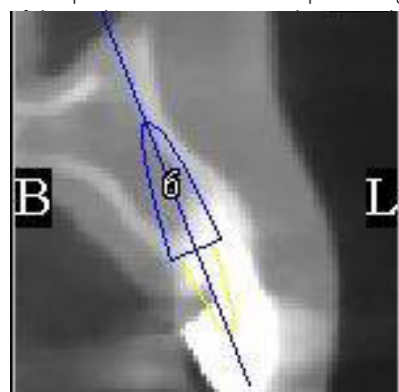
A cone beam CT scan was taken to visualize the implant site. Complete presence of the buccal plate was confirmed. Ideal positioning

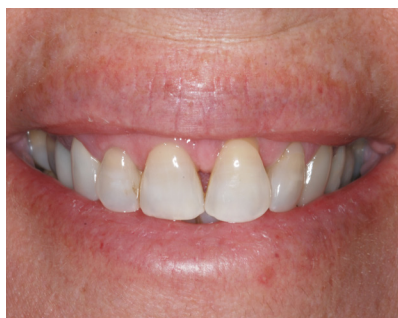
The patient points to tooth #6. A fistula is seen just below the free gingival margin of tooth #6. This tooth was restored with a porcelain fused to metal crown. A 5mm probing depth was measured at the fistula site. A vertical fracture could be felt through the base of the pocket at the fistula site. No tooth mobility was detected. An endodontic post can be seen on the periapical xray. On smiling, the patient has a moderate smile line with the soft tissue exposed apical to the free gingival margin.

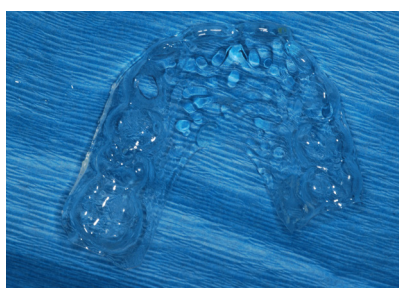
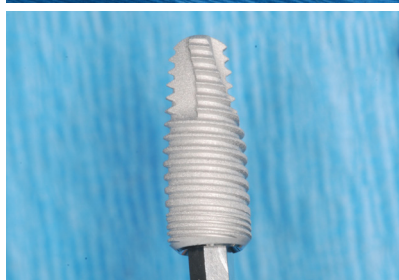
The surgical site was anesthetized with local anesthesia. Upon removal of the restorative crown, no coronal tooth structure was present. A Benex extraction tool was used to atraumatically extract tooth #6.

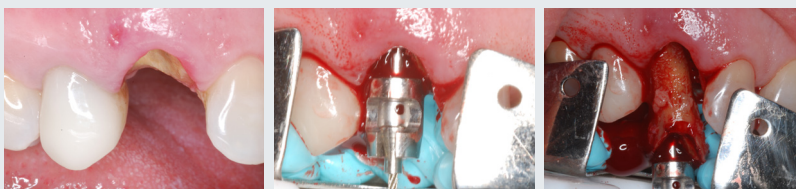
The extraction socket was thoroughly debrided with a large round carbide bur.

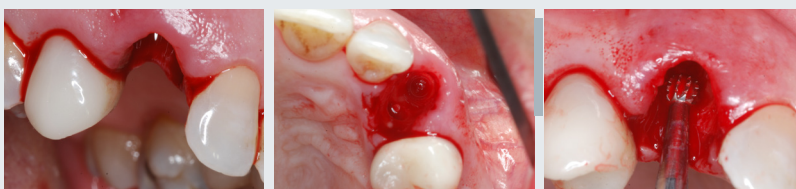
The pilot drill was used with the surgical guide to precisely position the initial osteotomy. This drill was ideally suited to penetrate the palatal socket bone.

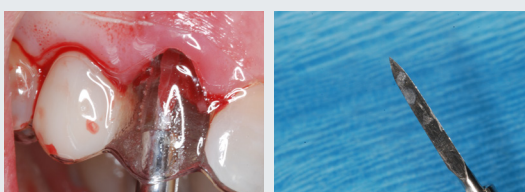
After initial use of the pilot bur, the maxillary bone was found to be soft. The decision was made to use the PALTOP Handpiece Driven Osteotomes to expand the initial osteotomy and condense the adjacent bone. This bone condensation provided greater implant stability. The PALTOP osteotome widths corresponded to the PALTOP stepped twist drill diameters.

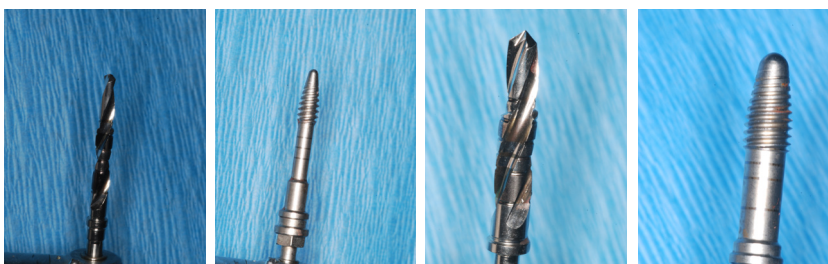
The depth of the buccal bone crest to the free gingival margin was measured to determine the vertical position of the implant head.

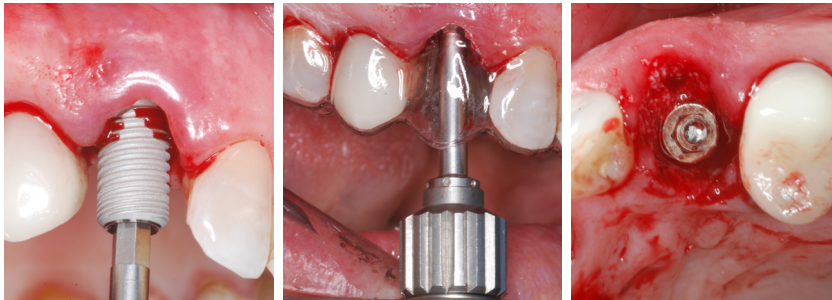
An Osstell measurement was taken to verify mechanical implant stability. A value of 78 was recorded, demonstrating high stability due to the large implant size and osteotome bone condensation. This Osstell value allowed for safe immediate provisionalization of implant #6.

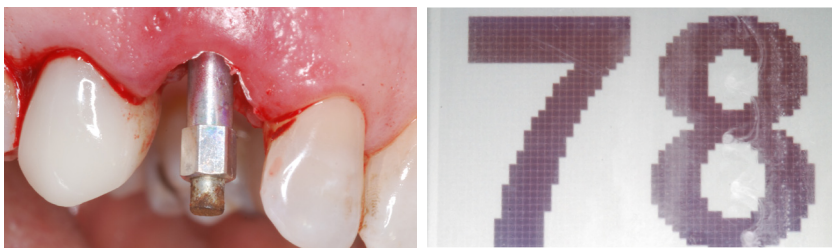
A PALTOP PEEK abutment with a 2mm concave collar height¹ was selected and inserted into the implant. Retention dimples were cut into the PEEK abutment. A cotton tip applicator was inserted into the screw access hole to prevent the relining acrylic from occluding the abutment screw. The acrylic shell provisional was tried in.

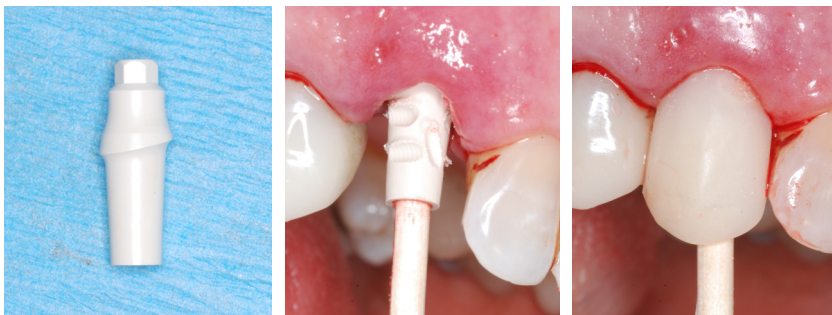
The provisional is relined with acrylic. After complete curing, the provisional is removed and deficiencies in the reline are seen. Acrylic is hand-painted into these deficiencies and the provisional is reshaped and polished.

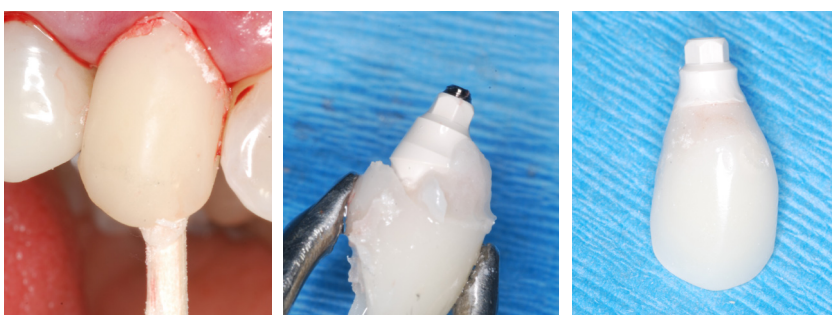
An autogenous subepithelial connective tissue graft was harvested from the patient's right palate.

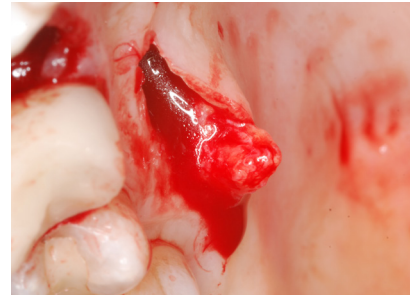
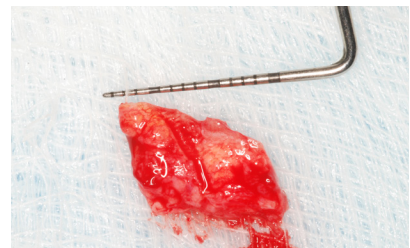
A buccal pocket is created in area #6 and the connective tissue graft is sutured into position.

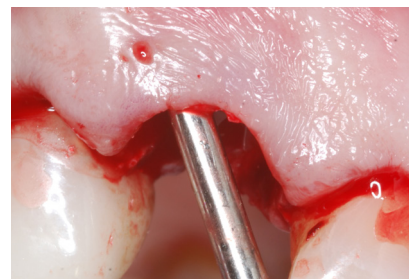
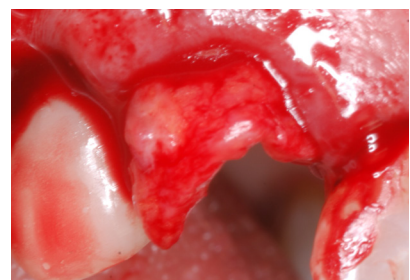
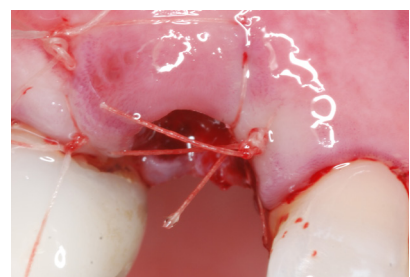
The concave PEEK collar design is continued into the relined acrylic provisional to maximize soft tissue healing. Ideal implant placement for a screw-retained restoration is obtained.

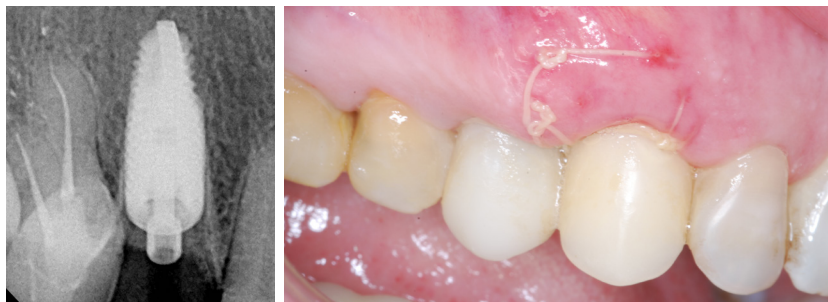
A full volume of healthy soft tissue can be seen. A nice soft tissue emergence profile was developed by using a **PALTOP concave provisional abutment²** with concave acrylic contours.

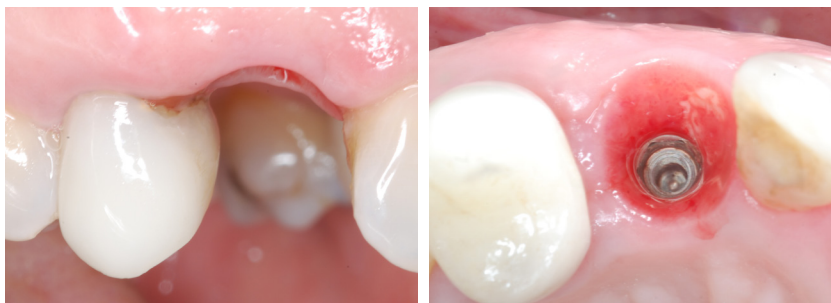
After 4 months of healing, a fixture-level impression was taken and a master soft tissue model was poured. A zirconia crown on a ti-base abutment was milled. The provisional crown contours are used to design the final zirconia crown contours.

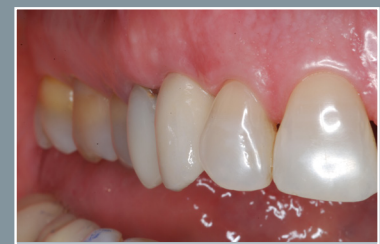
The mesial and distal papillae appear to be lost. However, probing depth to the bone in the embrasure spaces is 3mm. Over time these papillae will predictably fill to a soft tissue depth of 4 - 5mm from the bone. New soft tissue will fill the mesial and distal embrasure spaces.
